Report on the investigation of  
the entrapment of an engine room fitter  
in a watertight door  
on board the ro-ro passenger ship

***Eurovoyager***

approaching Ramsgate, UK

**Report 17/2009**  
**July 2009**

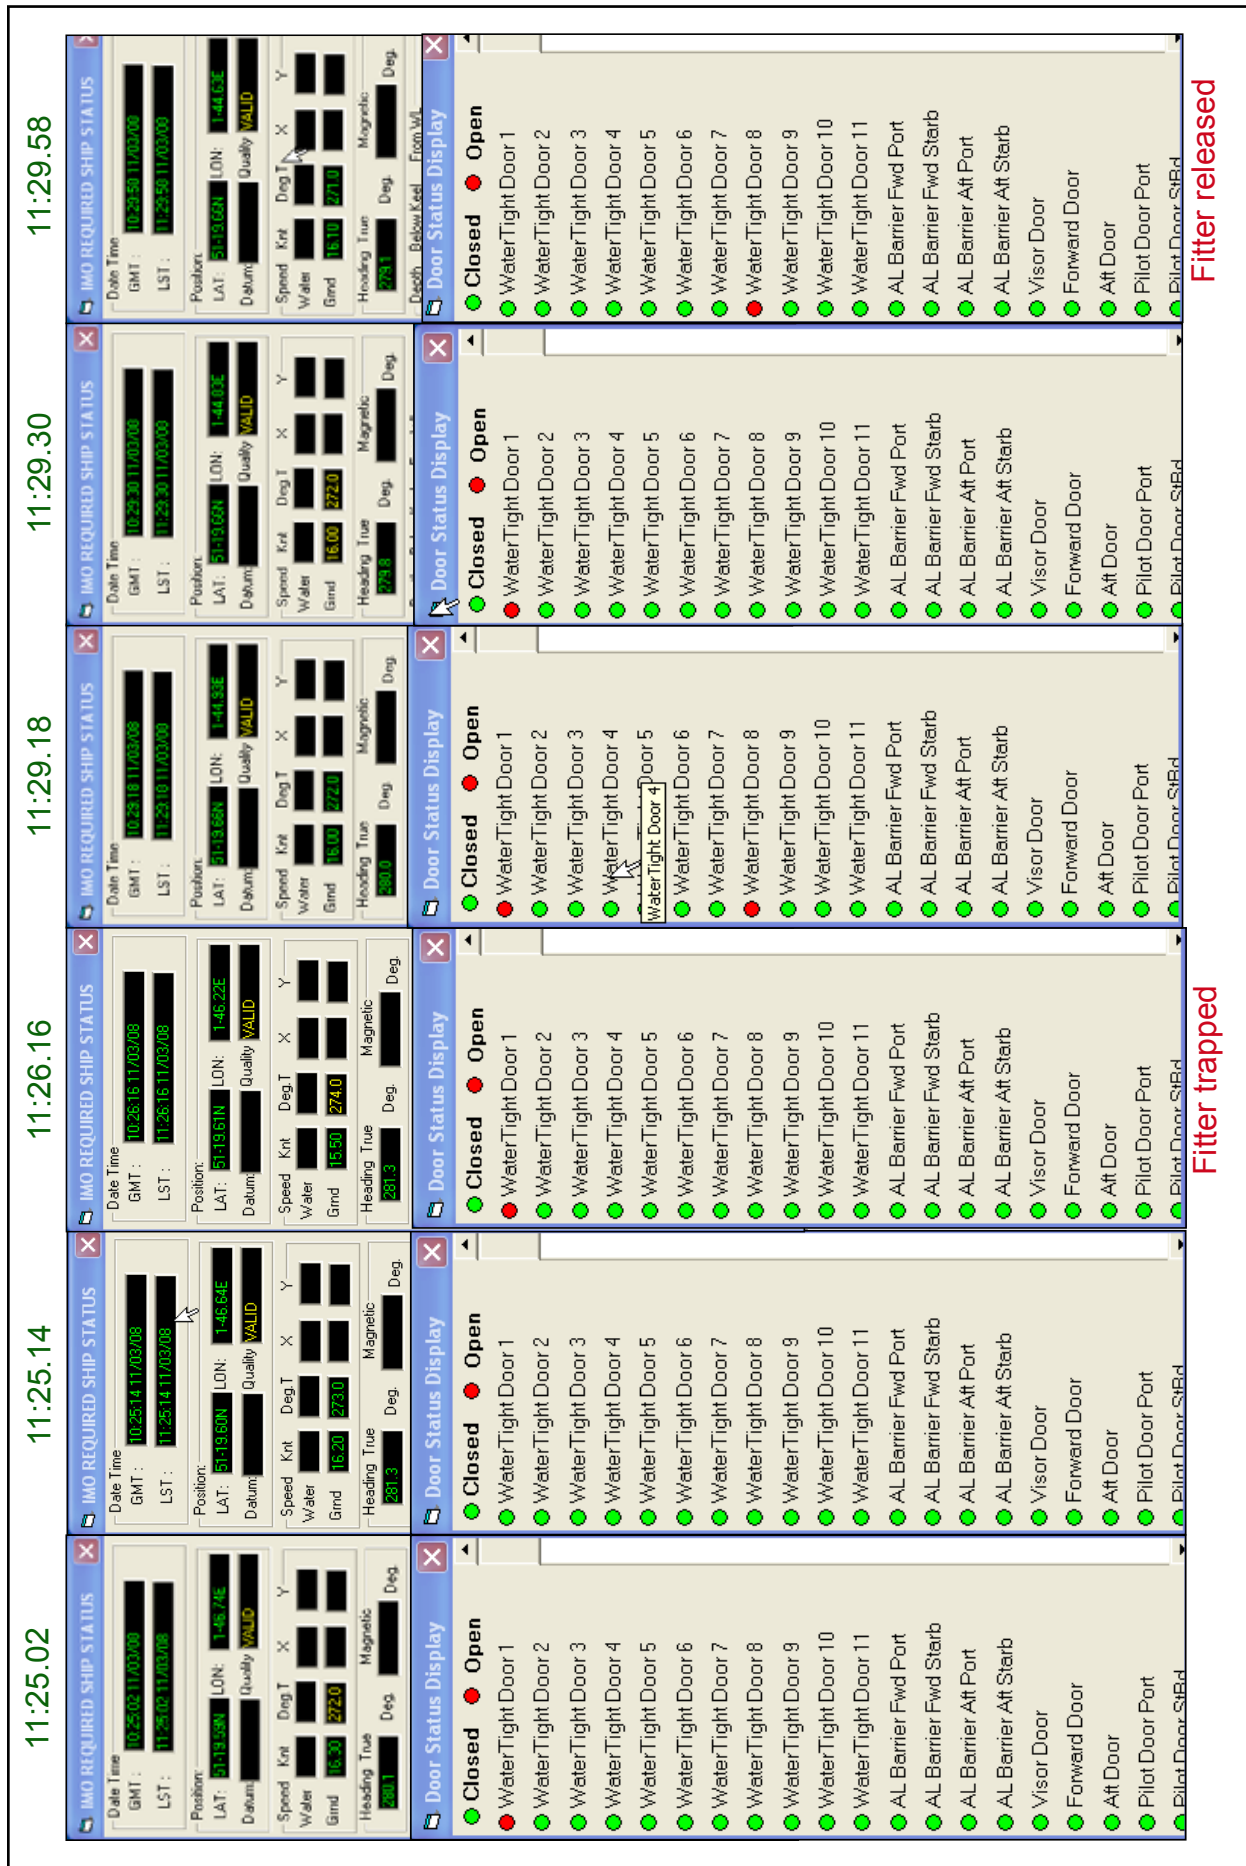
Extracts from the VDR, showing the status of the watertight doors

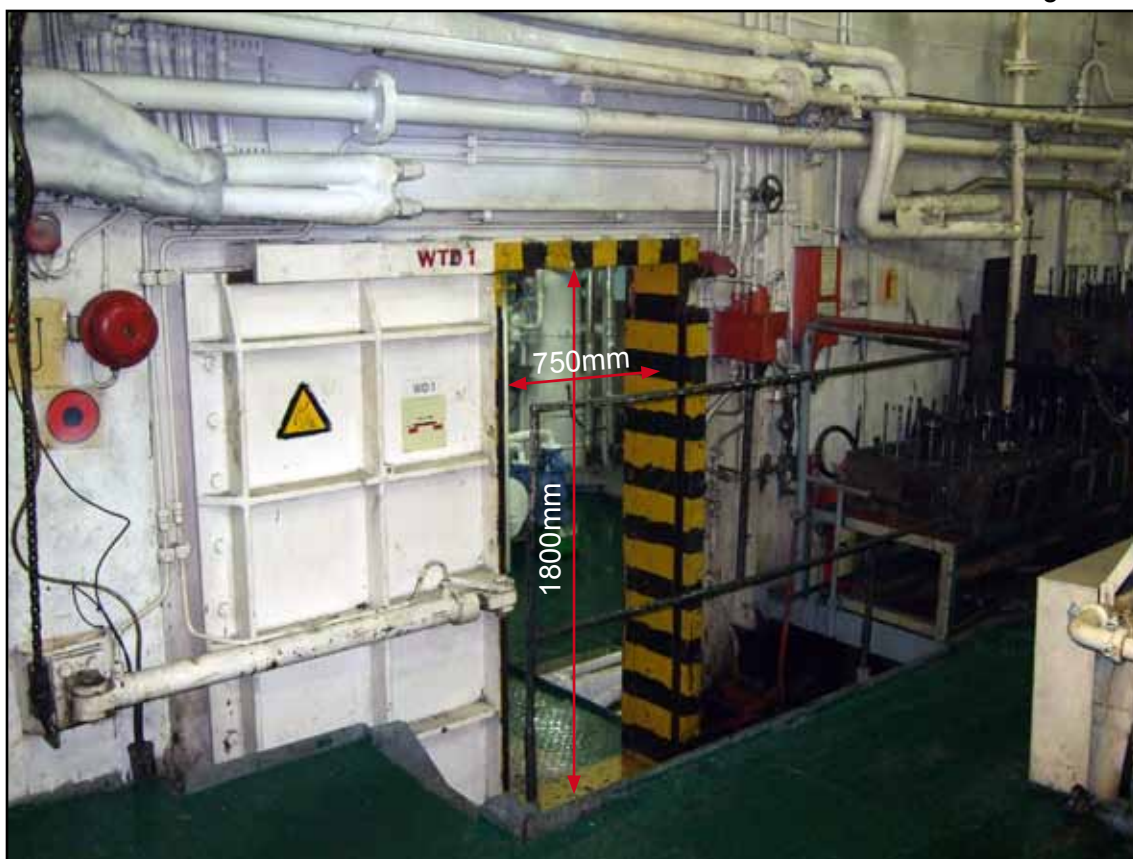
Figure 5a

There were 11 watertight doors, excluding the bow and stern doors and 4 weathertight deck barriers. Four of these doors were located in the machinery space (Deck 1), and the remaining 7 on Deck 2 (**Figure 4**). All of the doors were made of solid steel and were identical in construction except for two in the accommodation, which were narrower. WTD1 measured 1800mm x 750mm (**Figure 5**).

Photograph of watertight door No.1 (open) - view from auxiliary engine room

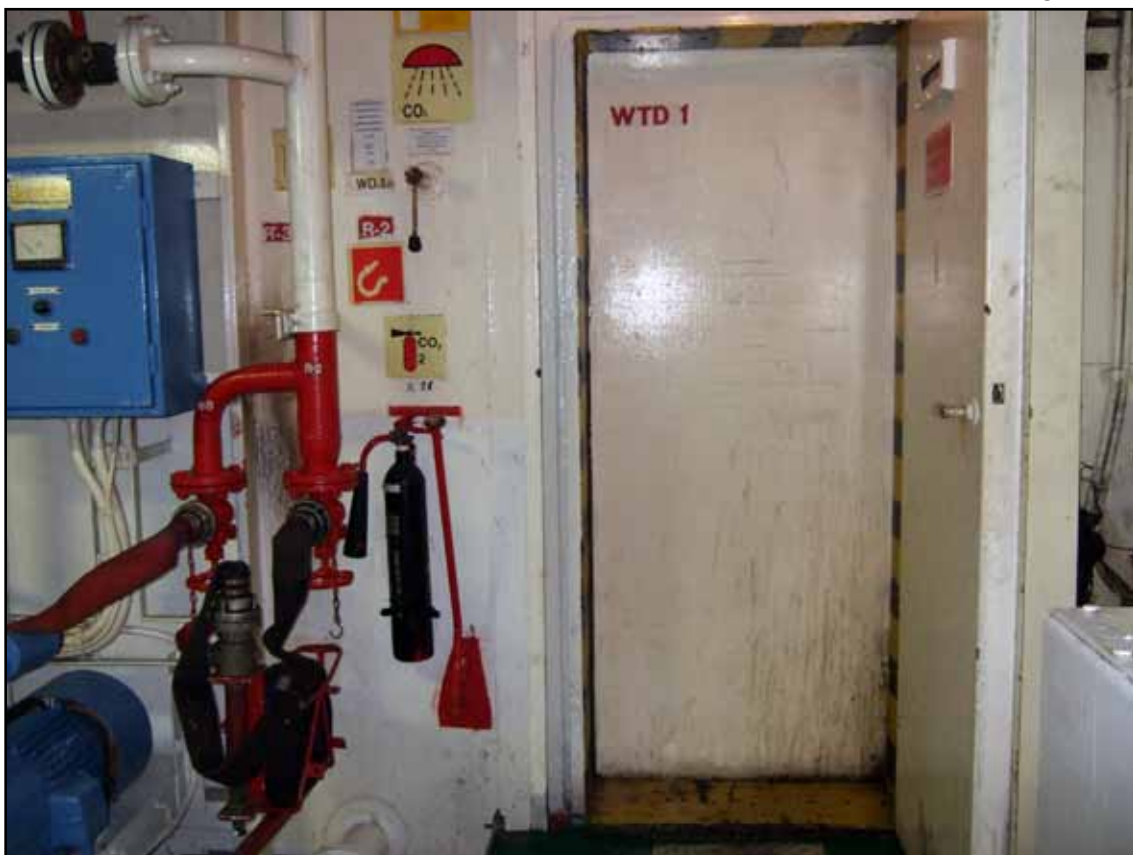
Figure 5b

Photograph of watertight door No.1 (closed) - view from changing room

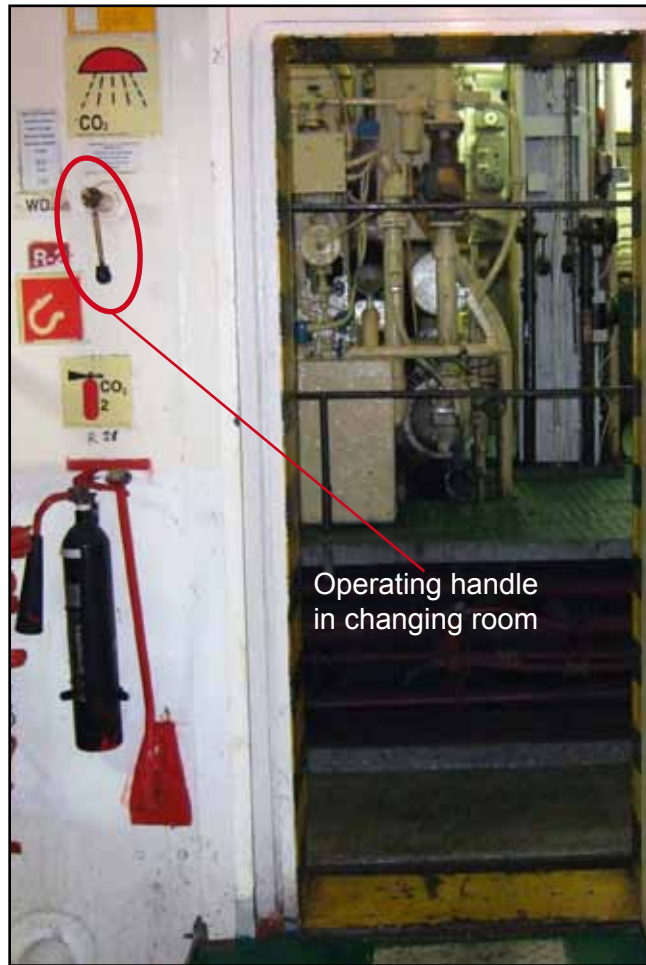
Figure 6a

Operating handle  
in changing room

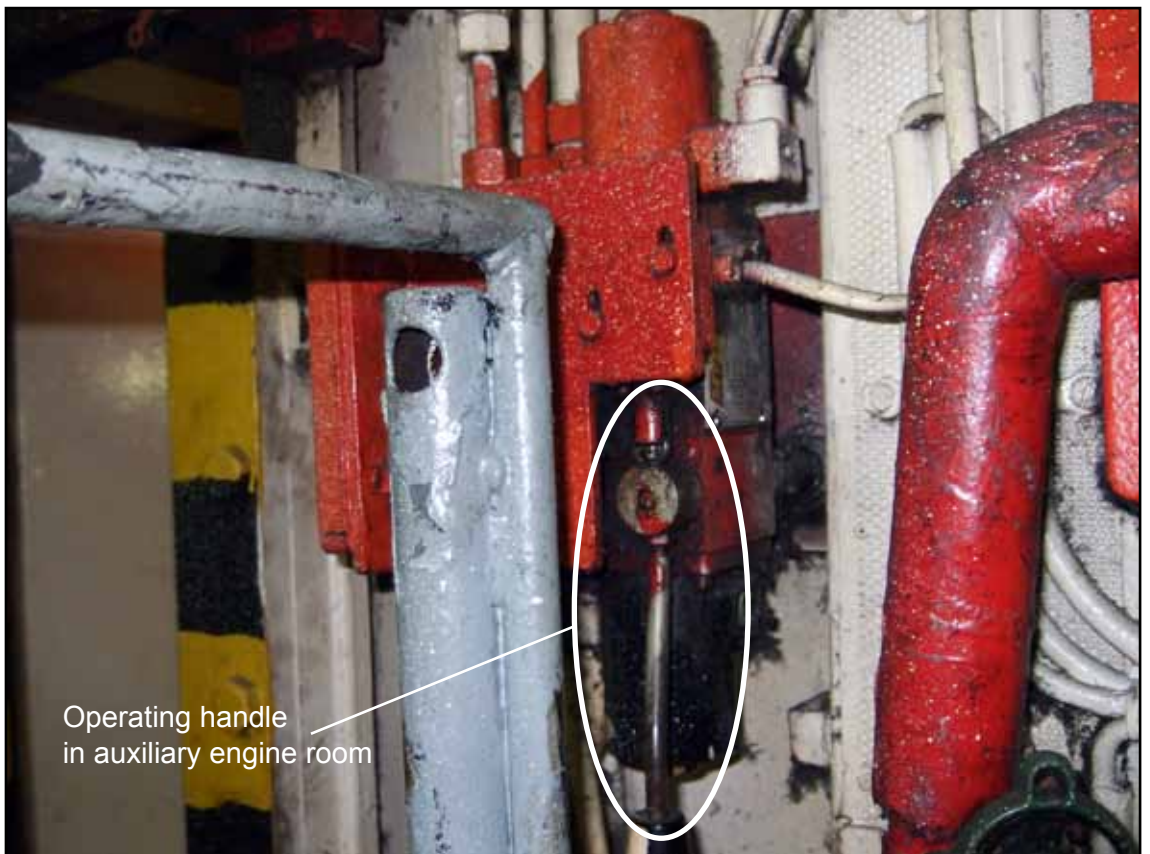
Figure 6b

Operating handle  
in auxiliary engine room

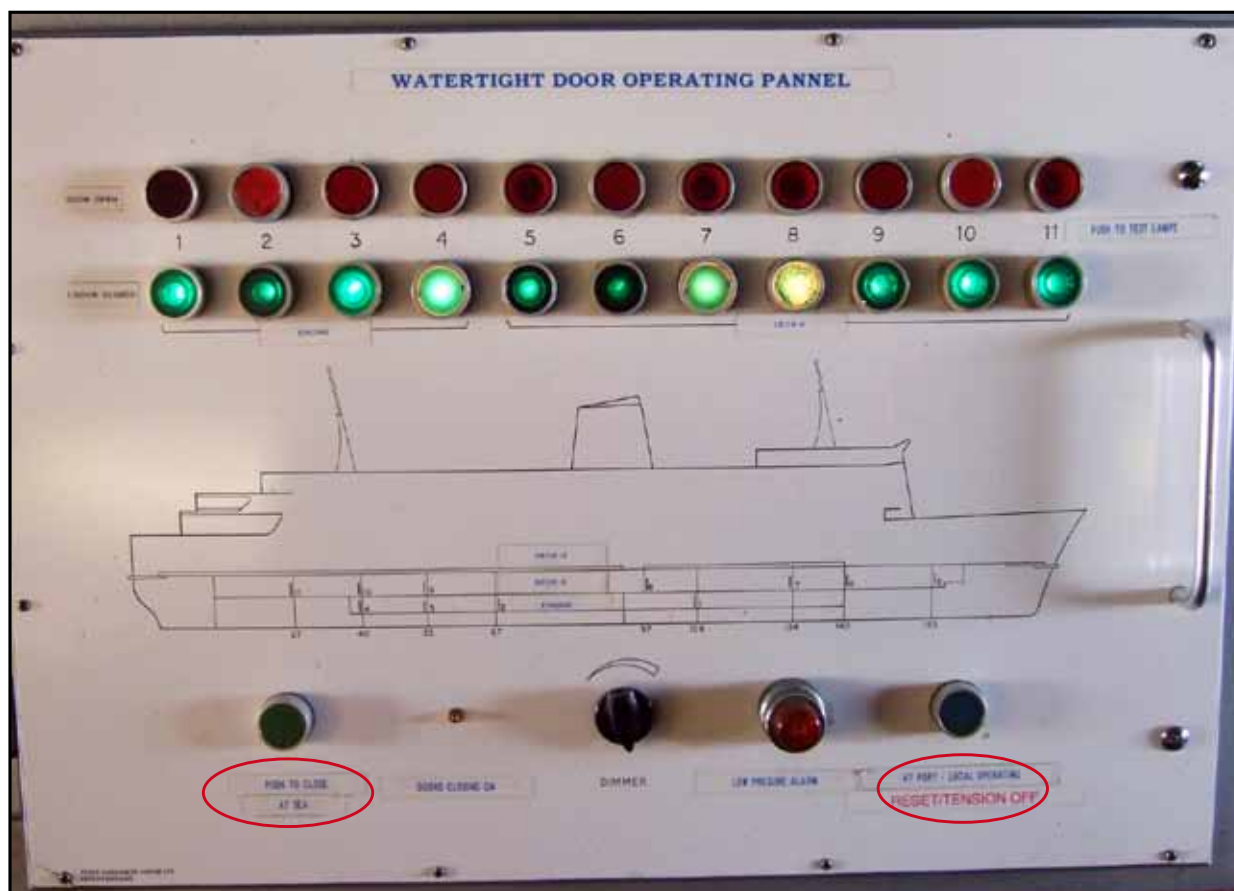
Watertight door operation panel

- The presence of an unapproved damage control information booklet.
- The ambiguous labelling on the operating console.

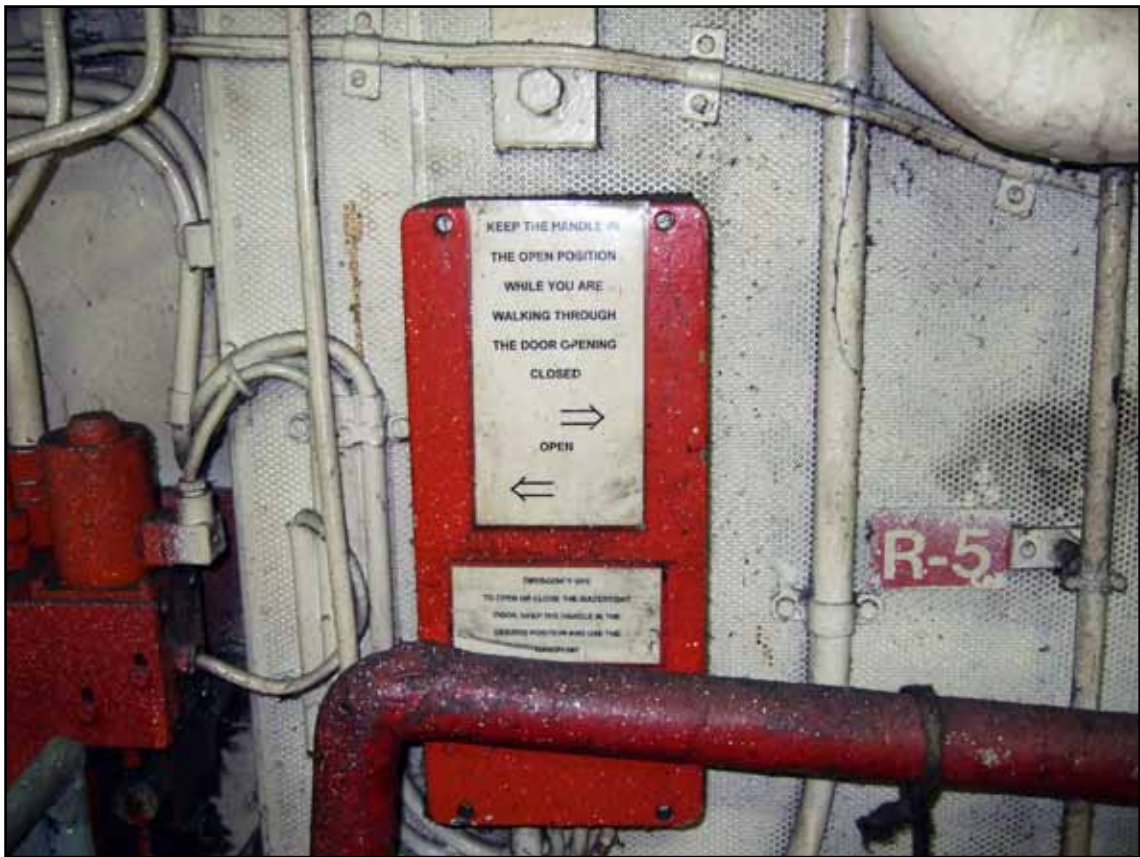
Emergency operating procedures and instructions were available on either side of each watertight door stating that the operating handle was to be kept in the open position while transiting the door (**Figure 8**). There were no instructions to open the door fully before passing through it. Furthermore, there were no posters or notices to indicate the potential dangers of entrapment if the correct transit procedures were not followed.

Instructions for transiting the watertight doors

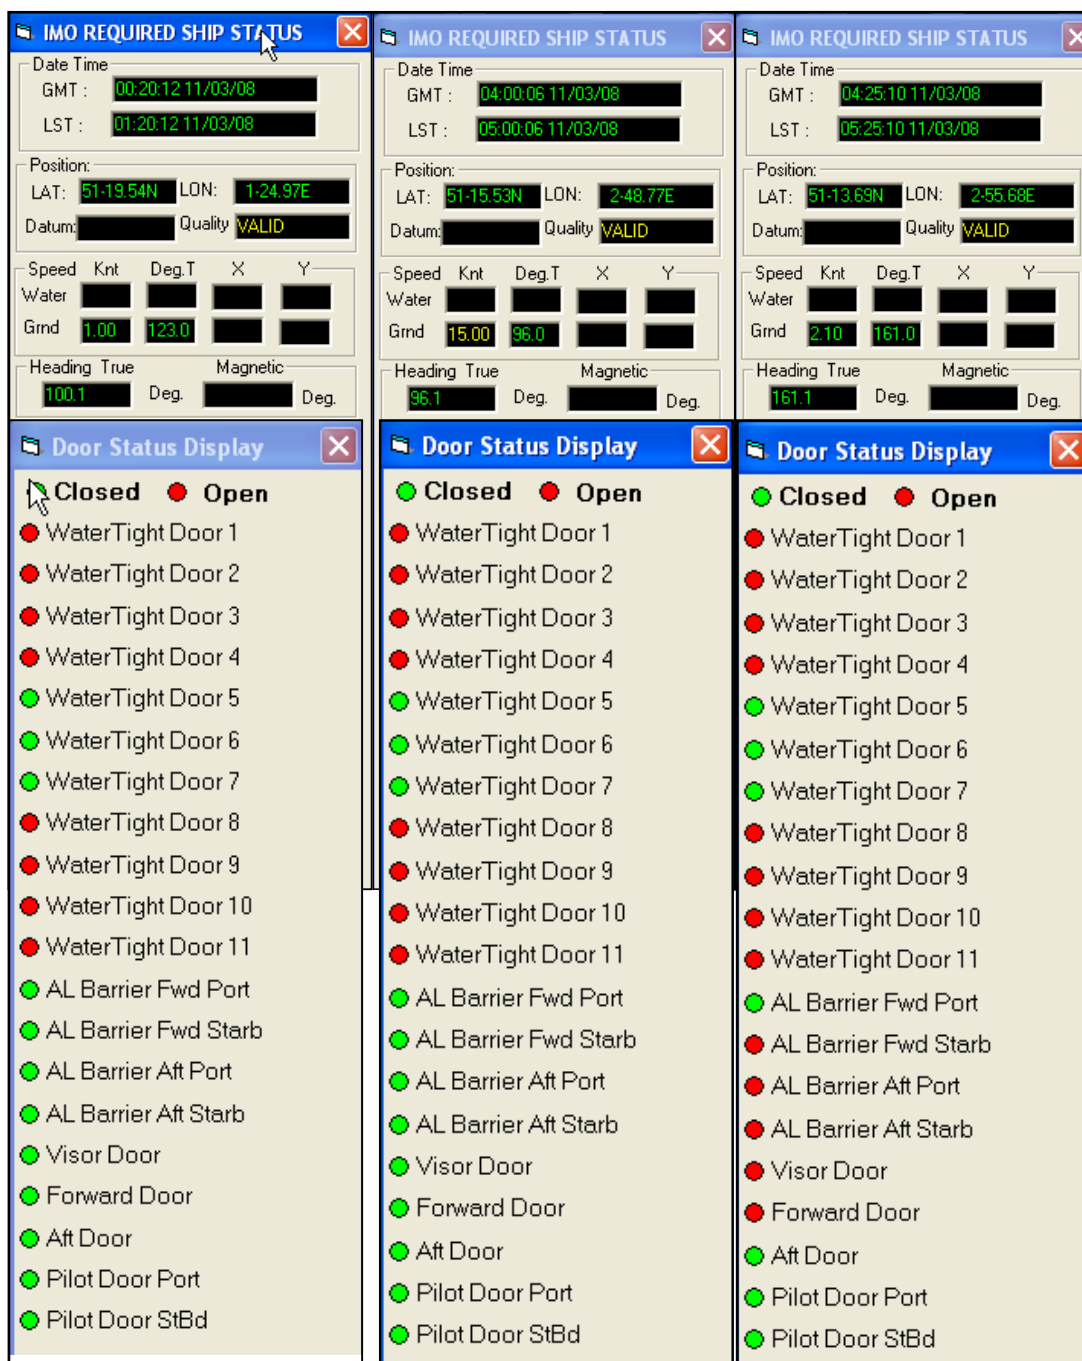
Figure 9

Extract of VDR data showing the status of the watertight doors on the vessel's previous passage

However, all of *Eurovoyager's* watertight doors were required to be kept closed at sea, and the number left open during her voyage prior to the accident is of concern. Moreover, the similar status of the doors found in the VDR data recovered during the annual performance checks from as early as 2003, indicates that this was a long-standing practice. Not only did the crew fail to close doors after passing through, the indication on the door operating console on the bridge showing that the doors were open was ignored. For a vessel operating in the Dover Strait, which is one of the world's busiest waterways, such practices were potentially very unsafe.

2009/151 Adopt measures, including the review of VDR data, to ensure that its procedures for the operation of watertight doors are strictly observed.

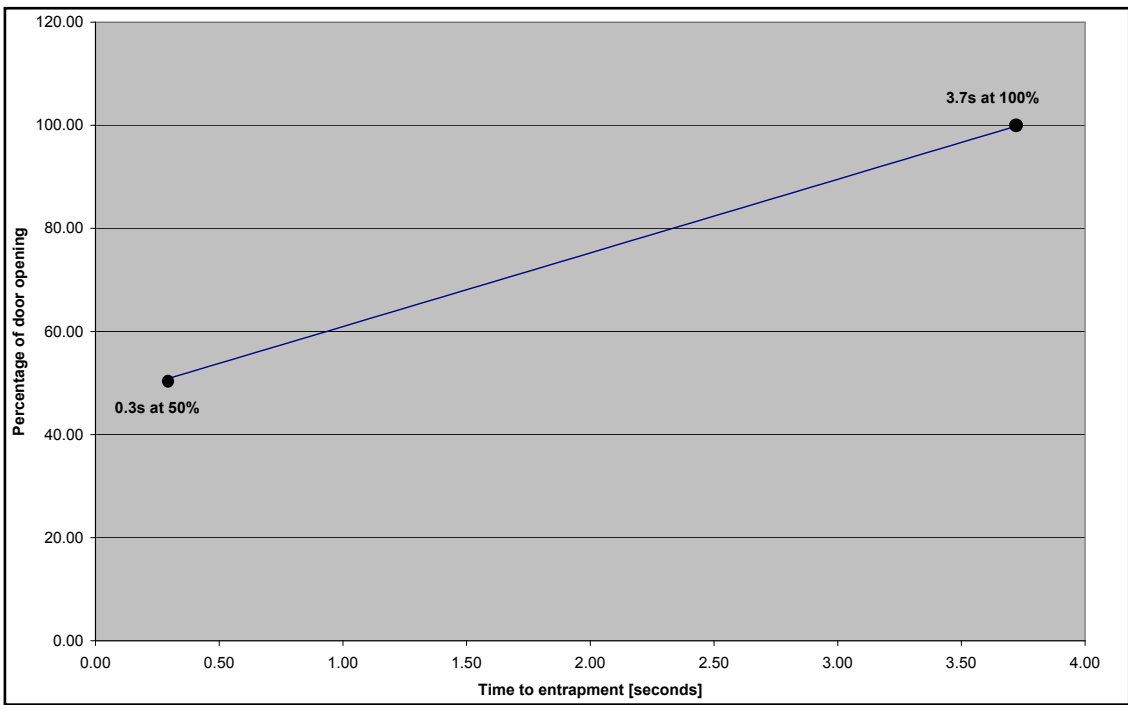
The position in which the fitter was found suggests that he only opened the watertight door by an amount which enabled him to pass through side-on, leading with his left shoulder. The door closure rate was almost three times faster than the rate required by ships built after 1992. Therefore, assuming a body depth of 35cm, he would have had 3.7 s to get through the door if fully opened, but only 0.3 seconds (**Figure 10**) if it was opened halfway. As the fitter was 6cm taller than the door opening, he is likely to have bent his knees when passing through, thus further reducing the time available.

Graph illustrating the relationship between transit time and door opening

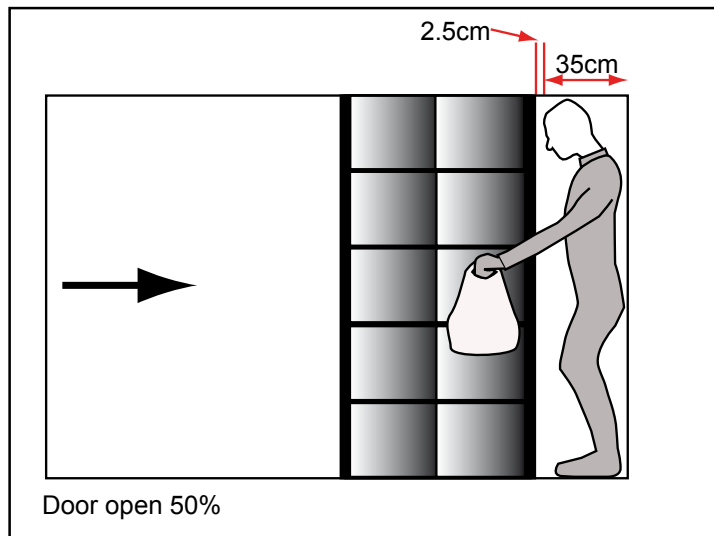
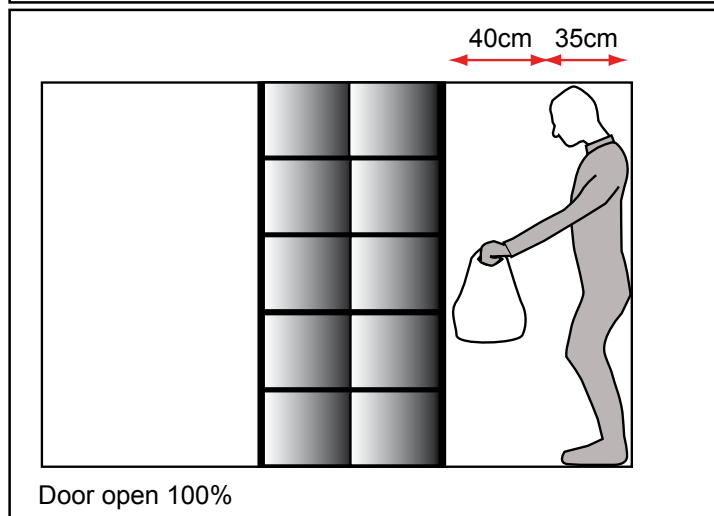
Door transit times and scenarios

Diagram of door transit scenario
